# Relative Accuracy of High precision Total Stations and DEMEC Gauges for Masonry Structures

Kallum Booth, Cally Pettiford and Matthew Whomsley, United Kingdom

**Key words:** Deformation Measurement, Engineering Survey, Remote Sensing, High Precision Structural Monitoring

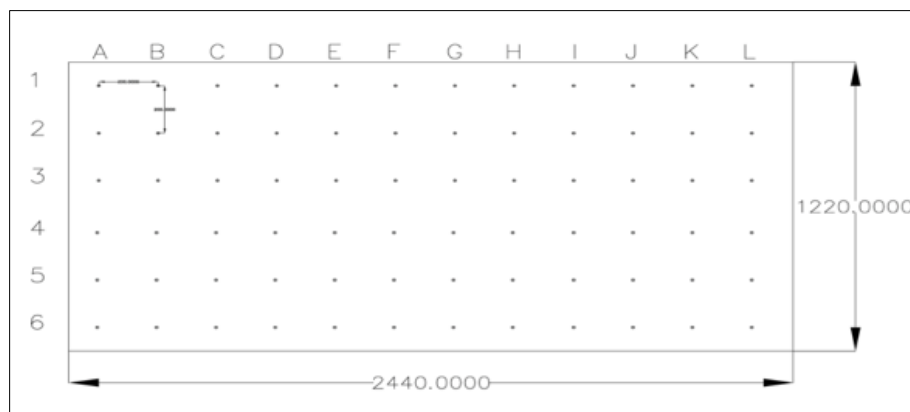
*Figure 1: Control Board Setting Out Diagram*

A control board was constructed from 2440 x 1220 x 25mm MDF (Medium Density Fibreboard). A 6 x 12 array of DEMEC studs was set out at 200mm centres to allow the comparison between the cumulative length of three consecutive 200mm DEMEC measurements and a single 600mm gauge measurement. With a gross weight of approximately 55kg and only use of manual handling available, the board size was limited. The dimensions represented a compromise, a span large enough to capture angular variability whilst compact enough to handle. The stud setting out plan was produced using Autodesk AutoCAD at 1:1 scale (Figure 1). The drawing was edited during conversion to PDF, removing margins and conserving the scale to minimise errors during printing. Due to small tolerances in the DEMEC gauge, perpendicularity between studs must be maintained.
