# **Integrating Laser Scanning, BIM, and Virtual Reality (VR) Technologies for Monitoring and Restoration of Existing Historical Structures**

**Hanniel Tetteh DJABA, Ghana  
Krzysztof KARSZNIA, Poland**

**Keywords:** laser scanning; BIM; gaming technologies, structural monitoring

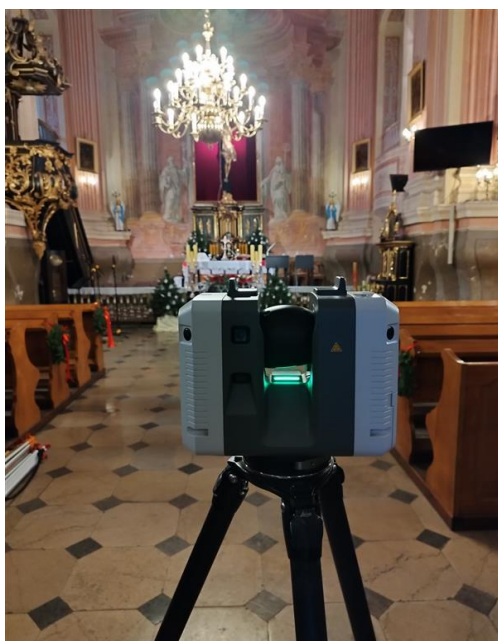
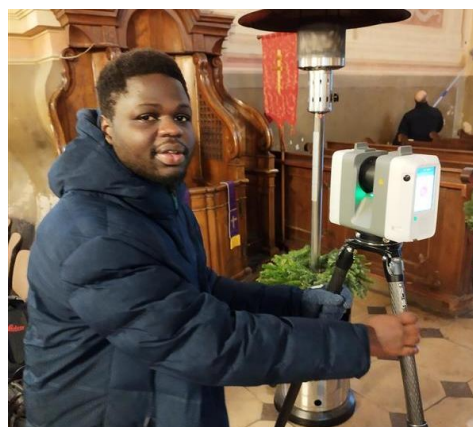
Fig. 1 Lector RTC 360 Scanner at the abbey to Capture Point Clouds

- **Data Acquisition:** high-resolution 3D scans were obtained using the Leica RTC360 scanner as shown in Fig. 1.
- **Data Processing:** point cloud data were cleaned, registered, and optimized for structural analysis.
- **BIM Model Development:** the structured data was used to create a digital representation of the Abbey.
- **Immersive Visualization:** the finalized BIM model was visualized using gaming technologies.

The Leica RTC360 terrestrial laser scanner was used for data acquisition, providing high-precision 3D point clouds of the Benedictine Abbey (Fig. 1). The abbey has dimensions of length 27 meters, a width of 9 meters, and a height of 20 meters. The scanner was positioned at multiple locations within the abbey to ensure full coverage of the interior of the structure, including architectural details, floor levels, and observable structural deformations.

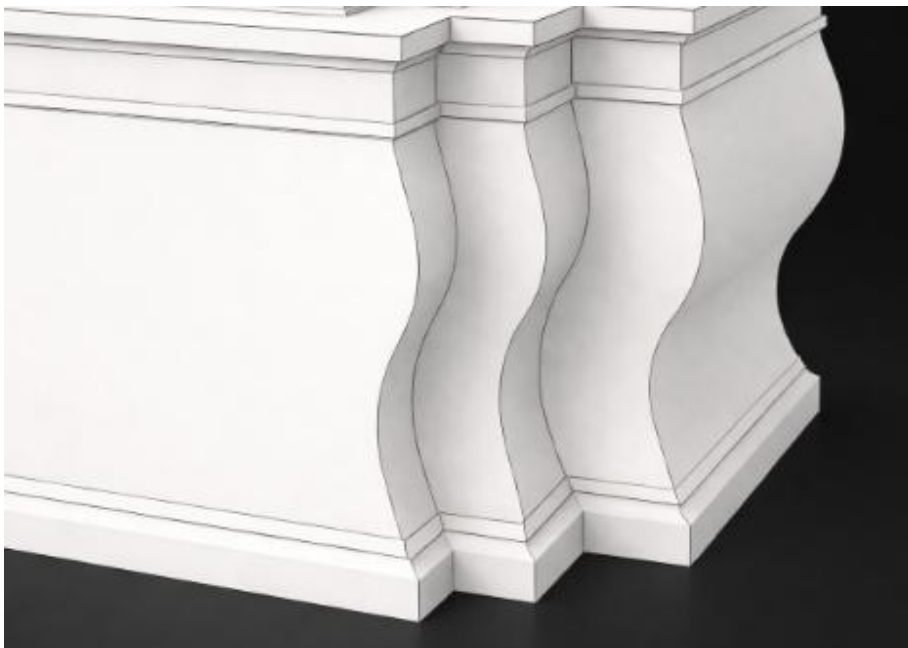
Fig. 6 An example of the final point cloud-based BIM model (own elaboration)

Furthermore, the BIM model functioned as a comprehensive restoration and monitoring framework (Fig. 6), consolidating spatial data, historical documentation, and engineering assessments into a unified digital environment. This data-driven approach enhanced decision-making for conservation teams by enabling scenario testing, prioritization of interventions, and long-term planning based on quantifiable structural performance indicators.

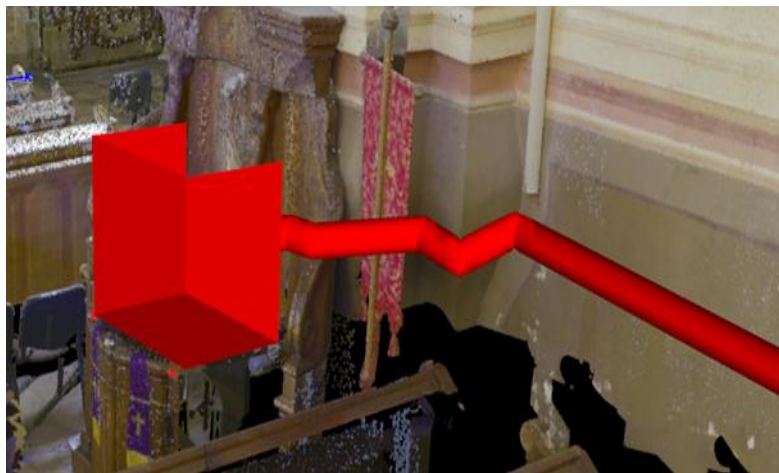
To strengthen safety precautions for the historic building, a fire hydrant system was created and incorporated into the BIM model as shown in Fig. 9 (in this particular case, it would be necessary to place the confessional in a slightly different location). As part of the fire safety plan, escape routes are analyzed to make sure they are structurally sound and properly designated. The viability of incorporating contemporary early-warning systems without sacrificing the building's historic integrity was also evaluated by modeling sensor-based fire detection systems in BIM. Using the Abbey's digital counterpart, simulations were run to assess fire evacuation scenarios and identify the safest and most effective ways for residents to evacuate. Modern suppression techniques, including misting systems, which effectively control fires while reducing damage to the structure's fragile materials, are also taken into account by the system. This all-encompassing strategy, which combines fire mitigation techniques with BIM-based risk assessment, greatly improves the safety of both people and the cultural site.

Fig. 9 BIM Model for proposed fire hydrant system (own elaboration)
